Re: Clean Water Act Pretreatment Inspection

SITE VISIT DATA SHEET

Name of Industry: Clean Harbors Los Angeles, LLC

Appendix 1
Clean Harbors Los Angeles
Photograph Log

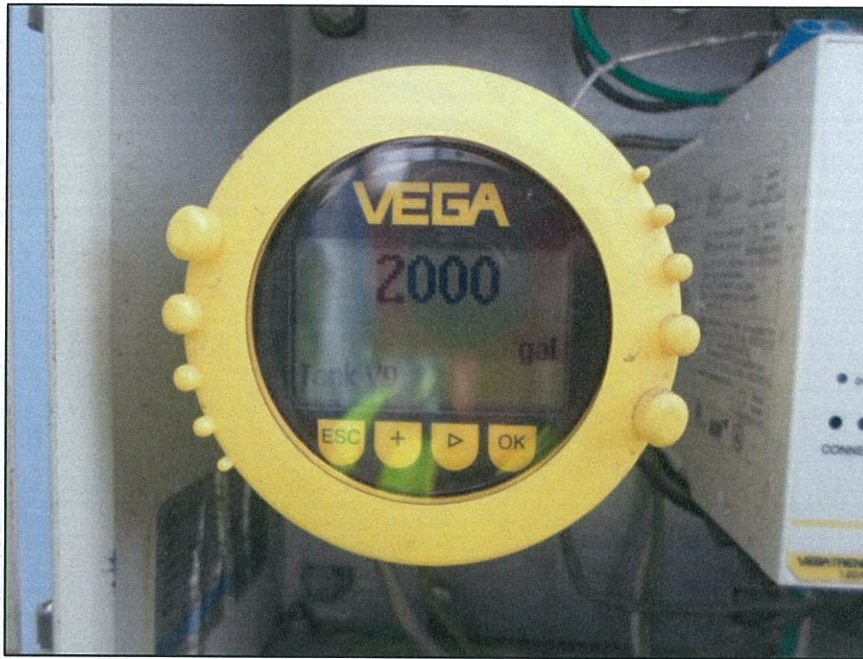
Photograph 1. View of the newly installed meter, displaying the volume of liquid stored within Tank V-9 at the time of the facility inspection.

4. During the inspection of the facility's waste storage area containing the process tanks and Tank V-9, the EPA Inspection Team observed that the facility kept a level meter log book to record the various levels of the tanks (refer to Attachment 2). The EPA Inspection Team reviewed the entries in the log book and noted that the entries recorded in the log book showed varying volumes of stormwater within Tank V-9. Some of the entries varied by as much as 8,180 gallons (July 1 and 2, 2015). The facility representatives explained that the facility had last discharged stormwater to the City's POTW during May 2015. The facility representatives further explained that the facility had been experiencing issues with the meter readings for the various tanks in the waste storage area, and had many of the level meters replaced.

- 5) It is recommended that the City follow-up with the facility and request and receive documentation showing when the level meters for the tank were replaced to confirm the varying levels of stormwater stored in Tank V-9 according to the log book.

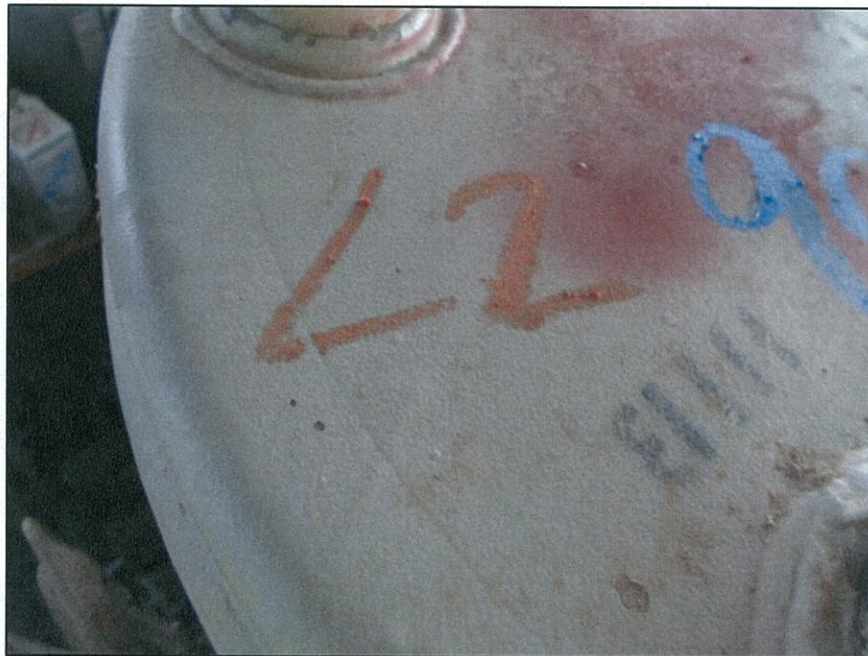
If the waste is accepted at the facility, the PCB concentration is written on the unit and a barcode is attached to the transformer/capacitor so the unit can be traced throughout the facility. Waste is collected and stored depending upon the concentration of PCBs within the oil. Oil with a PCB concentration of < 2 ppm is collected within one storage area and oil with a PCB concentration between 2 and 49 ppm is collected within another storage area of the facility. According to the facility representatives, units containing oils with PCB concentrations greater than or equal to 49 ppm are not accepted at this facility (refer to Photographs 2 and 3).

Photograph 2. View of a transformer containing transformer oil that has been analyzed and has a PCB concentration of <2 ppm. Note the markings with a grease marker made on the top of the unit.

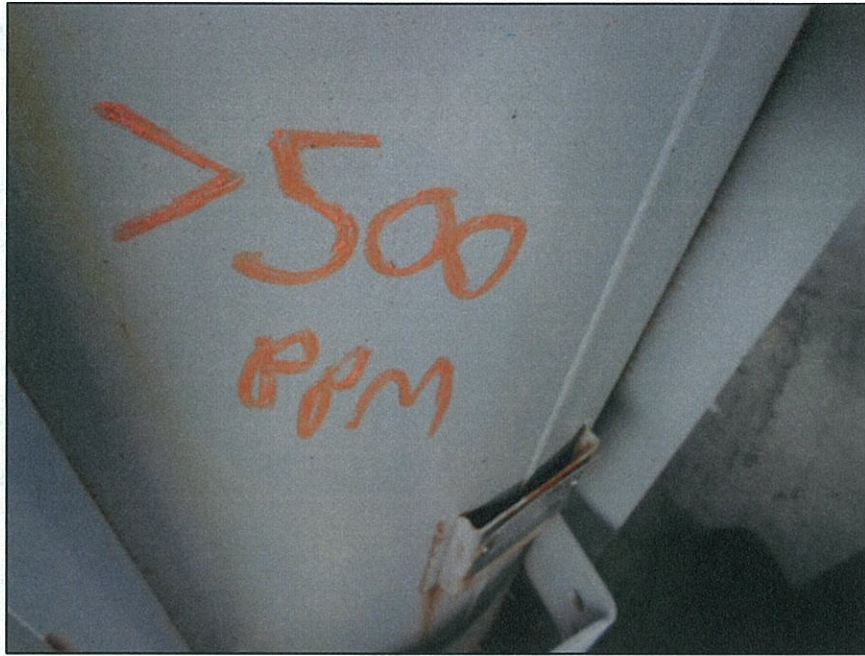
Photograph 3. View of a transformer unit stored at the facility's pumping pad. Note the grease marker states that the concentration of PCBs of the oil within the unit measure over 500 ppm. The facility representatives stated that some transformers are assumed to have a high ppm concentration even if the generator did not sample the oil. The facility analyzes a sample to identify the specific concentration of PCBs of the oil.

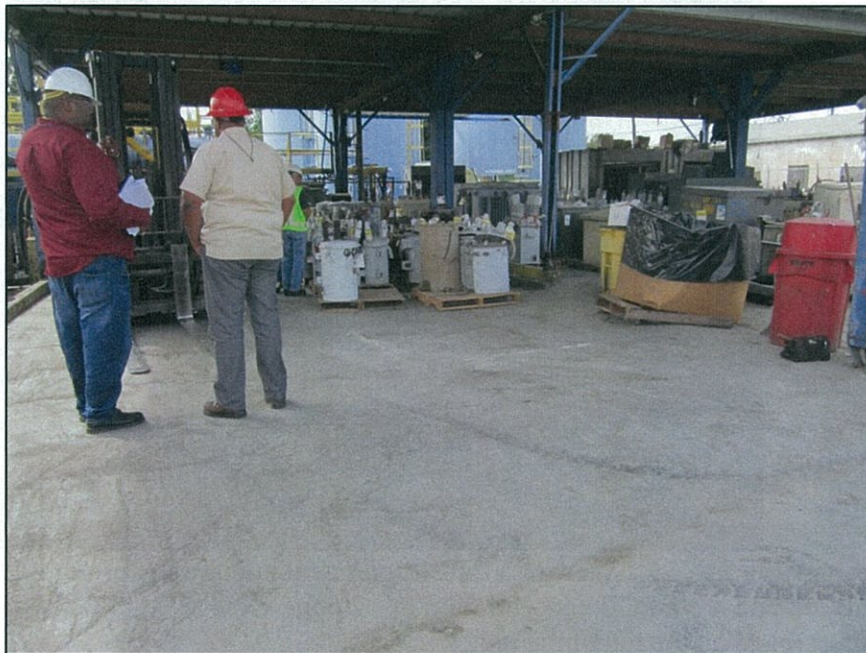
Units containing oil with a PCB concentration of <2 ppm PCBs would be pumped to Tanks V-1 and V-2. Oil from Tanks V-1 and V-2 was then pumped to Tank V-10, a 20,000 gallon holding tank and would be transferred to another facility for treatment and disposal. Units with oil that had a PCB concentration between 2 and 49 ppm would be pumped to Tanks V-3 and V-4. Oil from Tanks V-3 and V-4 was then pumped to Tank V-8, a 100,000 gallon holding tank for collection and transport to another facility for treatment and disposal (refer to Photographs 4 through 6)

Photograph 4. View, facing northwest, of the pumping pad located at the northcentral area of the facility. Note the overhead coverage provided for the area.

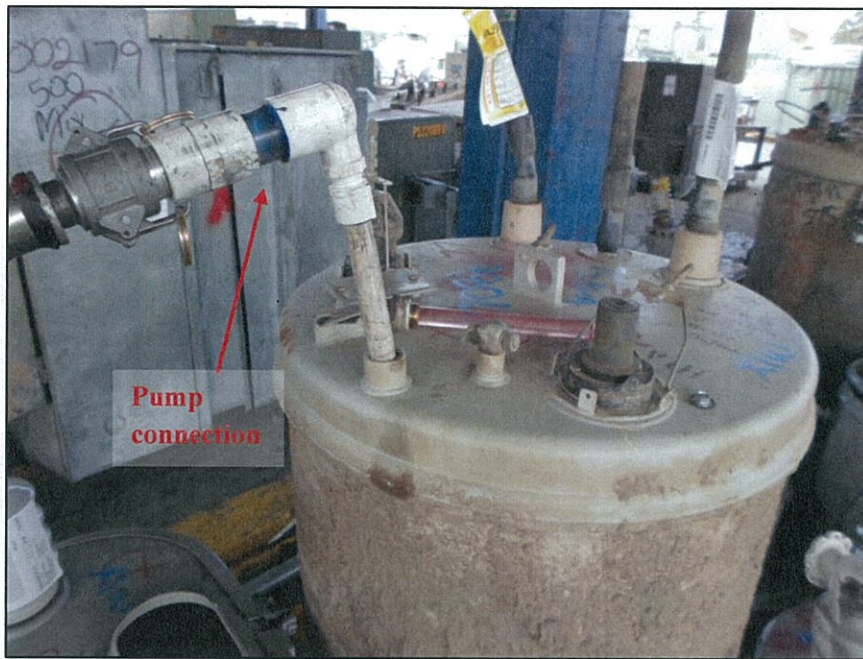
Photograph 5. View of a unit stored on the pumping pad at the facility. Note the oil was being pumped from the unit at the time of the inspection.

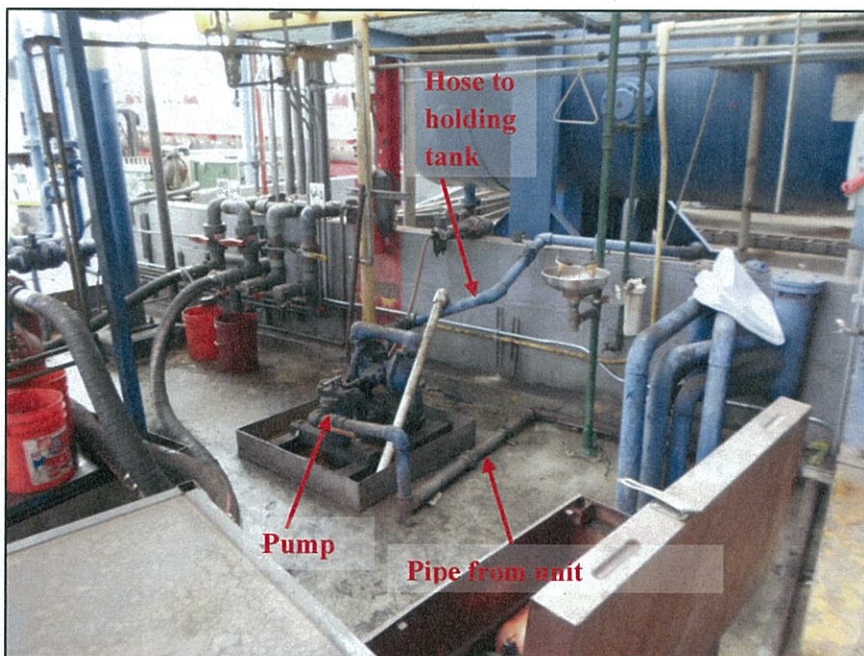
Photograph 6. View of one of the pumps located to the south of the pumping pad used to transport oil from the units to a holding tank.

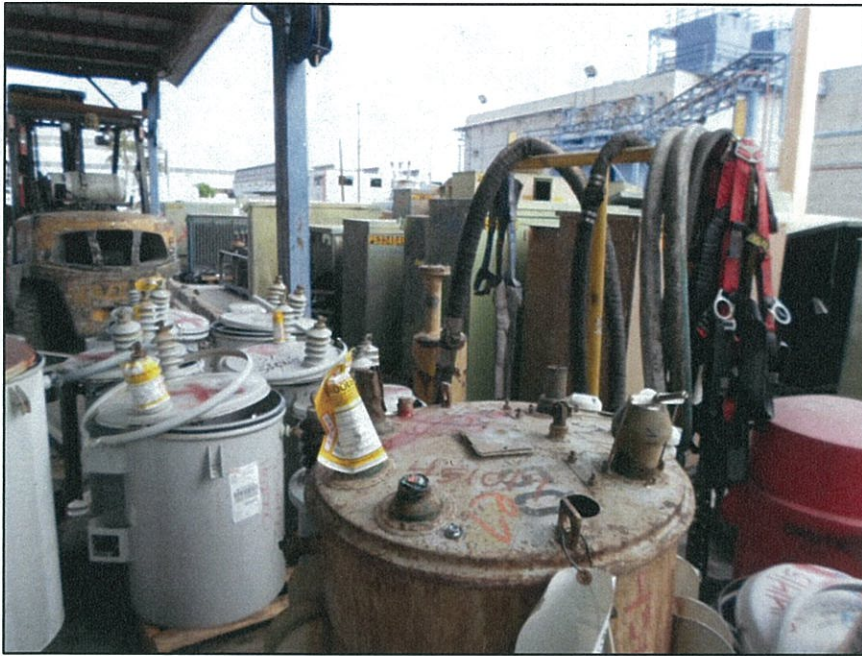
12. Are hazardous wastes drummed and labeled? Hazardous waste in the form of transformer/capacitor waste oil was received at the facility. Hazardous waste labels were attached to the outside of the transformer and capacitor shells (refer to Photographs 7 and 8).

Photograph 7. View of the covered pump pad located at the northcentral area of the facility. Note the units stored within the area waiting to have oil removed.

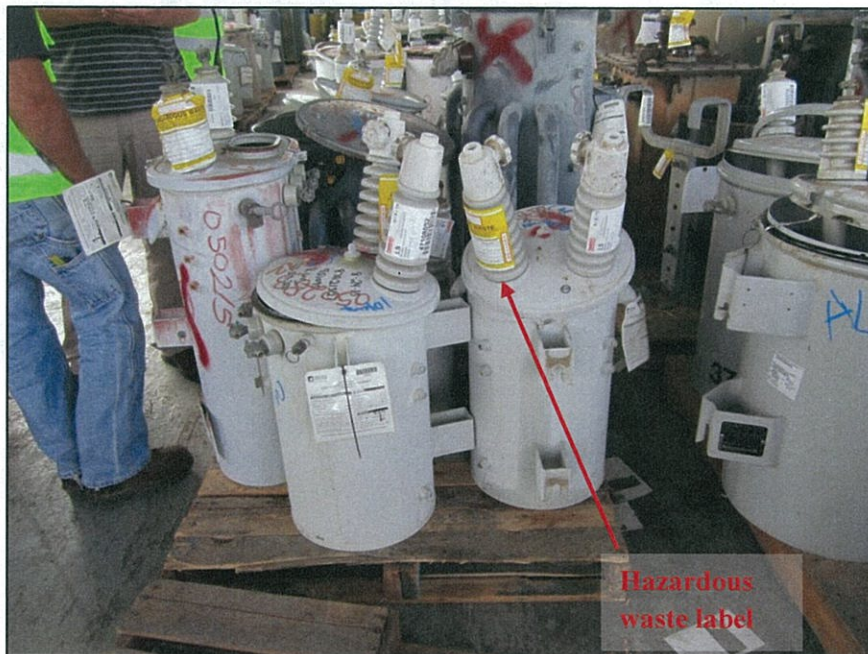
Photograph 8. View, facing west, of the units stored in the pumping pad area with overhead coverage. Note the units are marked and equipped with hazardous waste labels.

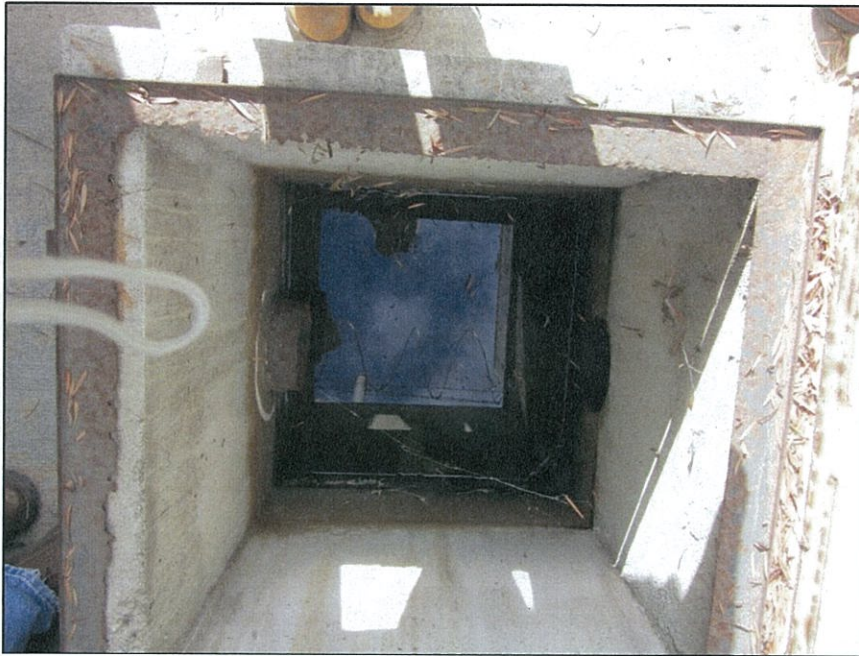
15. Description of sample location: The facility's sampling point was located at a two-stage sampling box located to the west of the facility, outside of the facility's fence line. The facility was not discharging stormwater to the City's POTW at the time of the inspection (refer to Photograph 9).				
Sampling method/technique: Grab and composite samples were collected at the facility's sampling location.

Photograph 9. View, looking down at the facility's final sampling location for stormwater discharges to the City's POTW. The sampling point was located outside of the facility's fence line.

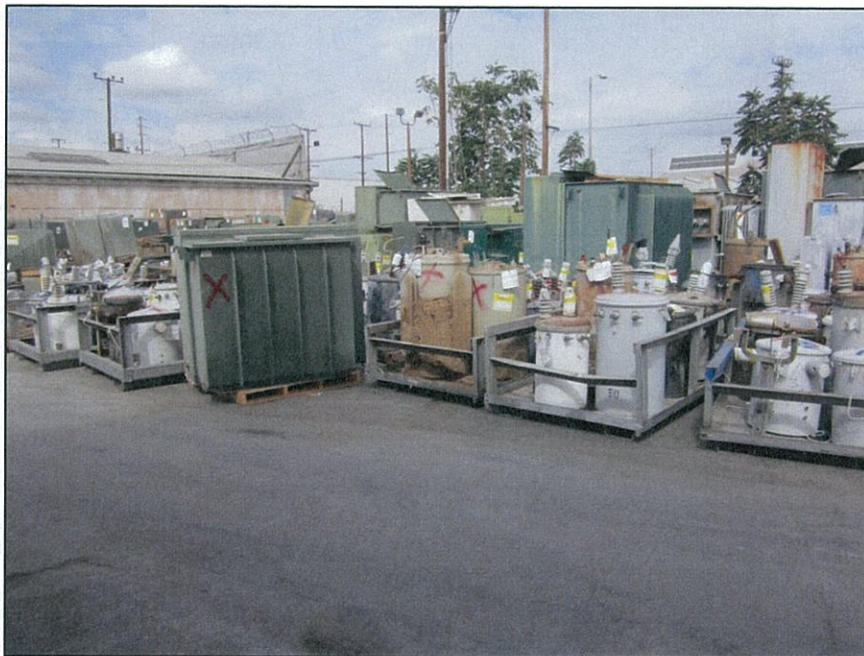
Photograph 10. View, facing northeast, of transformers and capacitors accepted at the facility and stored within the facility's storage yard. Note the lack of overhead coverage provided for the units stored within this area of the facility.

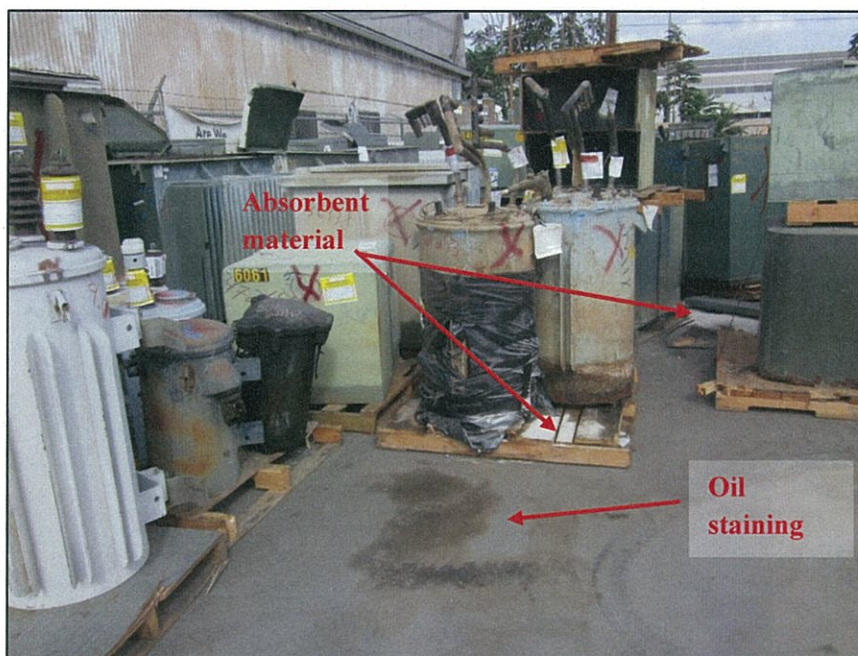
3. During the inspection of the process area to the northeast of the pumping pad, the EPA Inspection Team identified multiple transformers that were leaking oil. The oil was actively leaking from one of the units. Evidence of past spills or leaks was also present on the pavement. The facility had applied solid absorbent material to the oil, however, transformer oil was still actively leaking from one of the units (refer to Photographs 10 through 14). The facility representatives stated that they had procedures in place to address spills and leaks of transformer oil at the facility; however, it did not appear that they were being implemented. It is recommended that the facility implement and adequately adhere to its spill prevention and clean up procedures to ensure that oils containing PCBs (i.e. hazardous waste liquids) are not leaking onto the pavement at the facility.

Photograph 11. View, facing east, of units located at the northeastern area of the facility. Note the oil staining on the pavement and absorbent material applied to the wooden pallet in the vicinity of the units within the process area.

- 3) It is recommended that the facility implement and adequately adhere to its spill prevention and clean up procedures to ensure that oils containing PCBs (i.e. hazardous waste liquids) are not leaking onto the pavement at the facility.

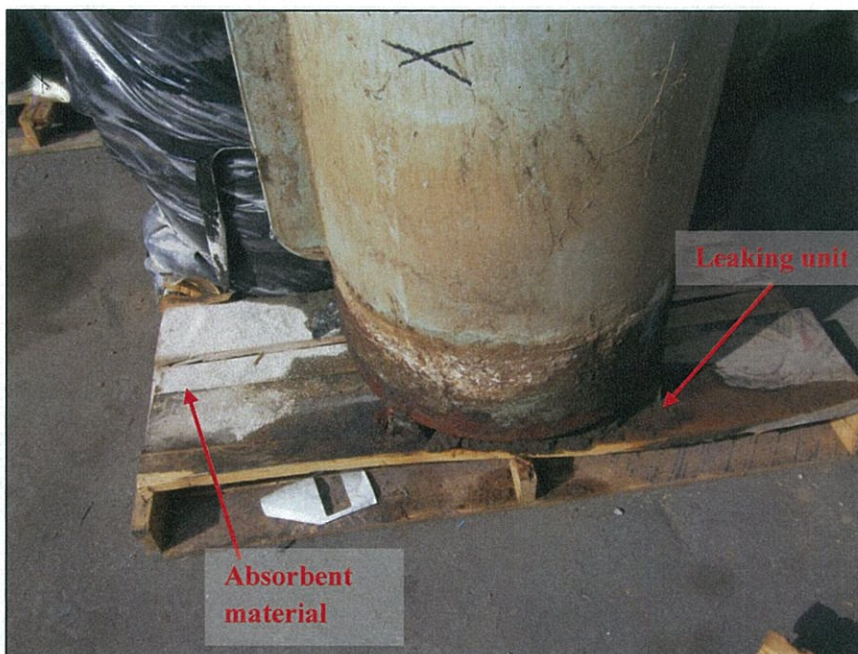
Photograph 12. Up close view of a leaking unit depicted in Photograph 11. Note the absorbent material applied to the pallet in the vicinity of the leaking unit.

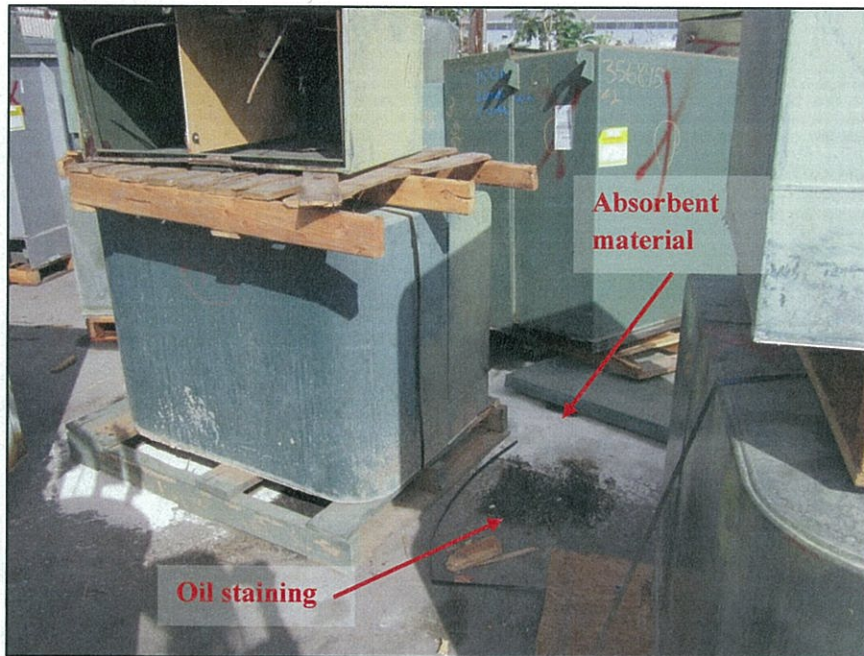
Photograph 13. Additional view of leaking units depicted in Photograph 11. Note the stained pavement and the absorbent material in the vicinity of the leaking units.

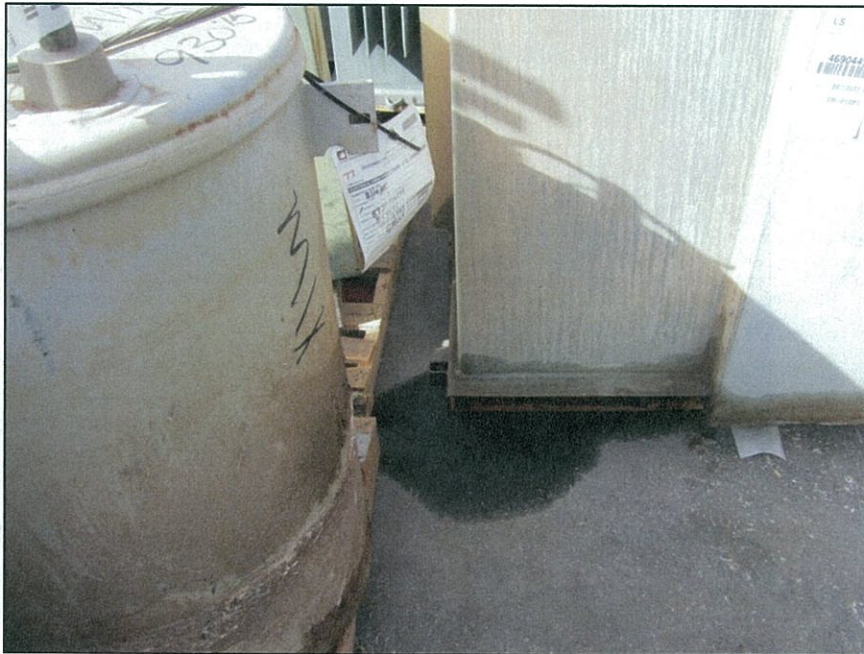
Photograph 14. View of the leaking units stored at the northeast area of the facility. These units were stored in the same vicinity as the transformers and capacitors depicted in Photographs 10 through 13.

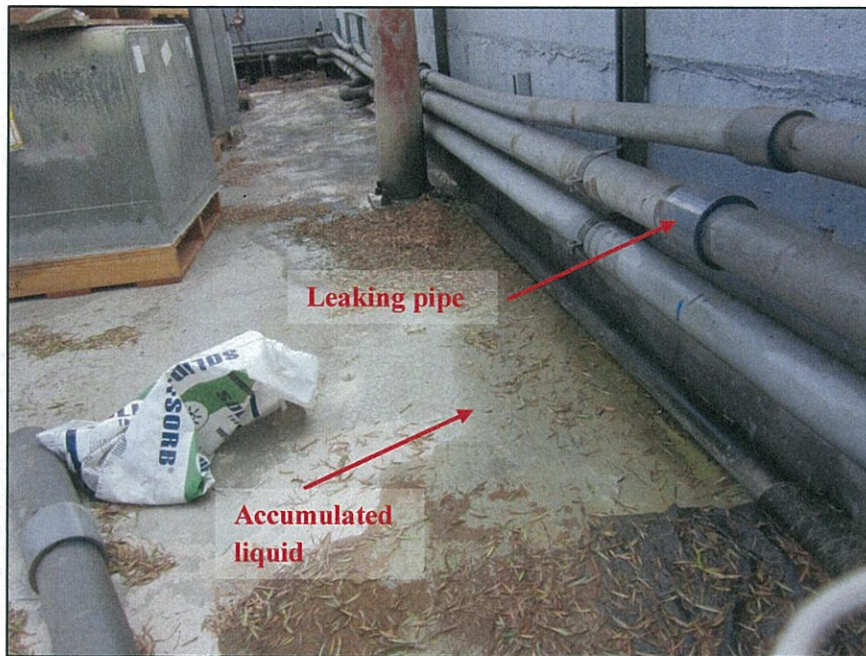
The EPA Inspection Team also observed a leaking pipe located at the southwestern area of the waste storage area where Tanks V-8, V-9 and V-10 were located. Leaking liquid dripped from the pipe and accumulated within the berm of the concrete pad and along the western and southwestern wall of the containment berm (refer to Photographs 15 and 16). The facility representatives explained that they had an electronic database system that was used to document inspections conducted throughout the process areas by facility representatives. The facility representatives also stated that in the event that the facility employees observed a maintenance issue, an entry would be generated in the facility's work order system and would be required to be addressed by a facility employee. According to the information provided from the facility's work order system, a work order had not been assigned to address the leaking pipe.

Photograph 15. View, facing west, of the leaking pipe and accumulated liquid from the leak at the western area of the waste storage area.

- 4) It is recommended that the facility ensure that it has the proper SOPs in place to identify, document, and respond to work orders and ultimately ensure that process equipment is adequately operated and maintained.

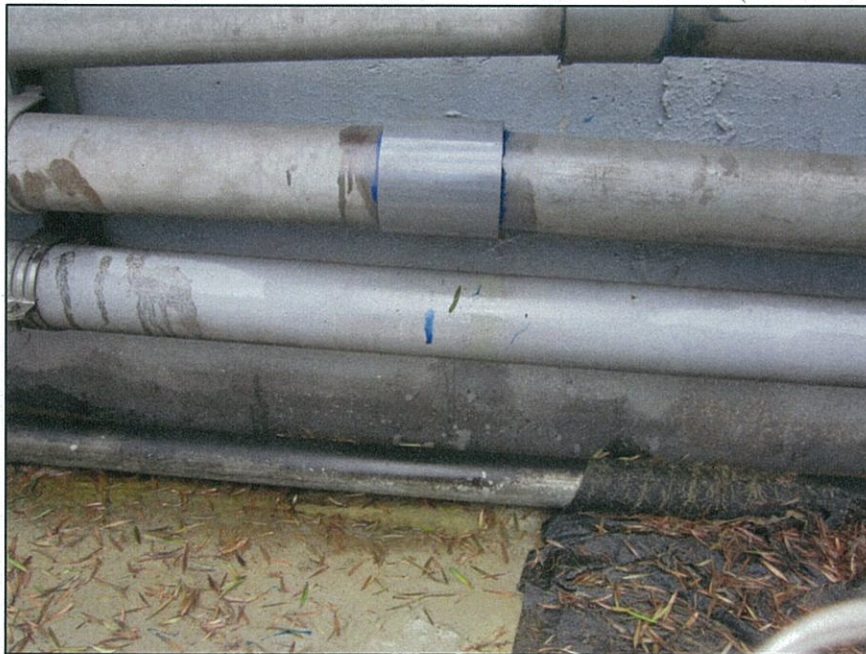
Photograph 16. Up-close view of the leaking pipe depicted in Photograph 15.
